## Startup/restart or shutdown operations: heightened vigilance

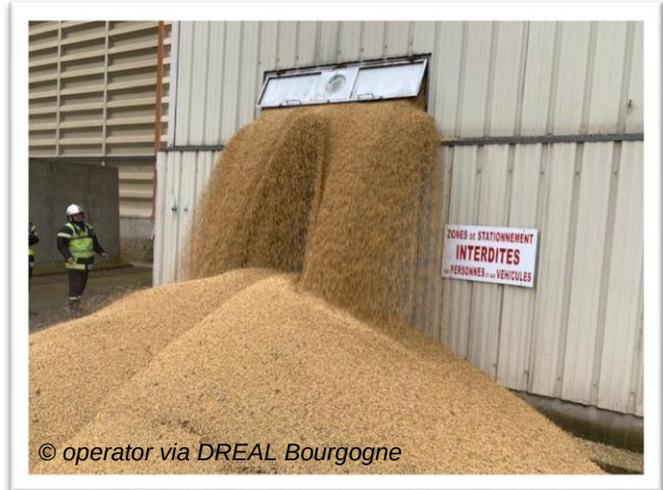
**ARIA 54897 – 12/12/2019 – CÔTE-D'OR:** 30 t of soybeans lost when a dryer is started (soybeans excessively humid at the reception point)

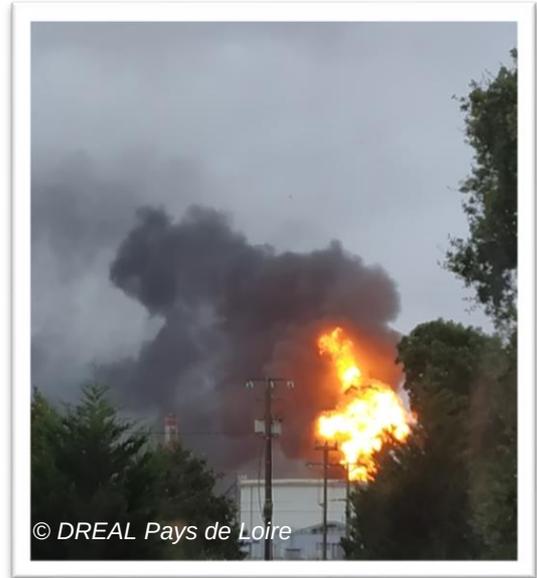
At 10:58 a.m. in a refinery, liquid diesel fuel ignited on a flare outlet **while the diesel fuel production unit was being restarted**.

The accident occurred shortly after the production unit was connected to the flare network. Following an overflow on a dryer vessel, the diesel fuel was sent to a buffer tank upstream from the flare. Both of these devices are equipped with high-level alarms. The alarms sounded but were not followed with actions (automatic or manual). The facility operator identified several malfunctions:

- **the technician assigned to these operations was having to handle major problems** on another unit at the same time. Consequently, he did not notify his shift supervisor, who was busy with other duties;
- although identified as an essential safety barrier, the technician did not correctly interpret the high-level alarm on the tank owing to his high stress;
- **incomplete procedures**: the procedure for restarting the diesel fuel unit was unclear regarding the steps required to start the dryer vessel, and the procedure for managing alarms did not include acknowledgement instructions.

*Large flames and a plume of black smoke were visible from afar.*

The operator took various actions following the accident:

- the restarting procedure was elaborated;
- **the ergonomics of the overview panels was improved to facilitate the detection of abnormal situations** and an extensive project was initiated to improve alarm management.
